The fire resistance performance of two single leaf single acting doorsets when tested in accordance with BS 476: Parts 20 and 22: 1987

408989

Falcon Panel Products Limited

21st January 2019

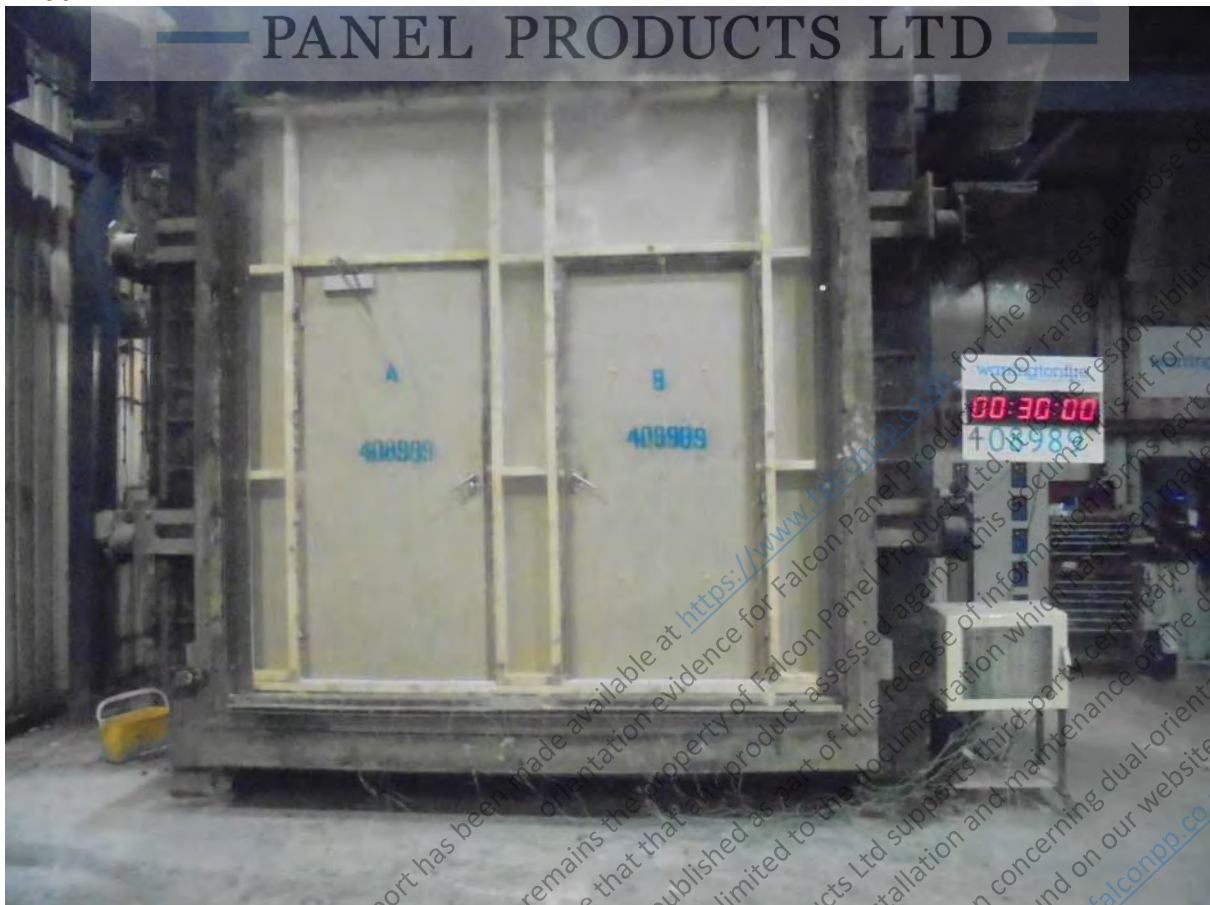
At 30 minutes

30:30	Both doorsets, fissures in the leaf approximately 5mm on the exposed face
42:10	Both doorsets, fissures in the leaf approximately 10mm on the exposed face
