The fire resistance performance of two, single-leaf, single-acting doorsets, when tested in accordance with BS 476: Part 20/22: 1987

414533

Falcon Panel Products Ltd

13th June 2019

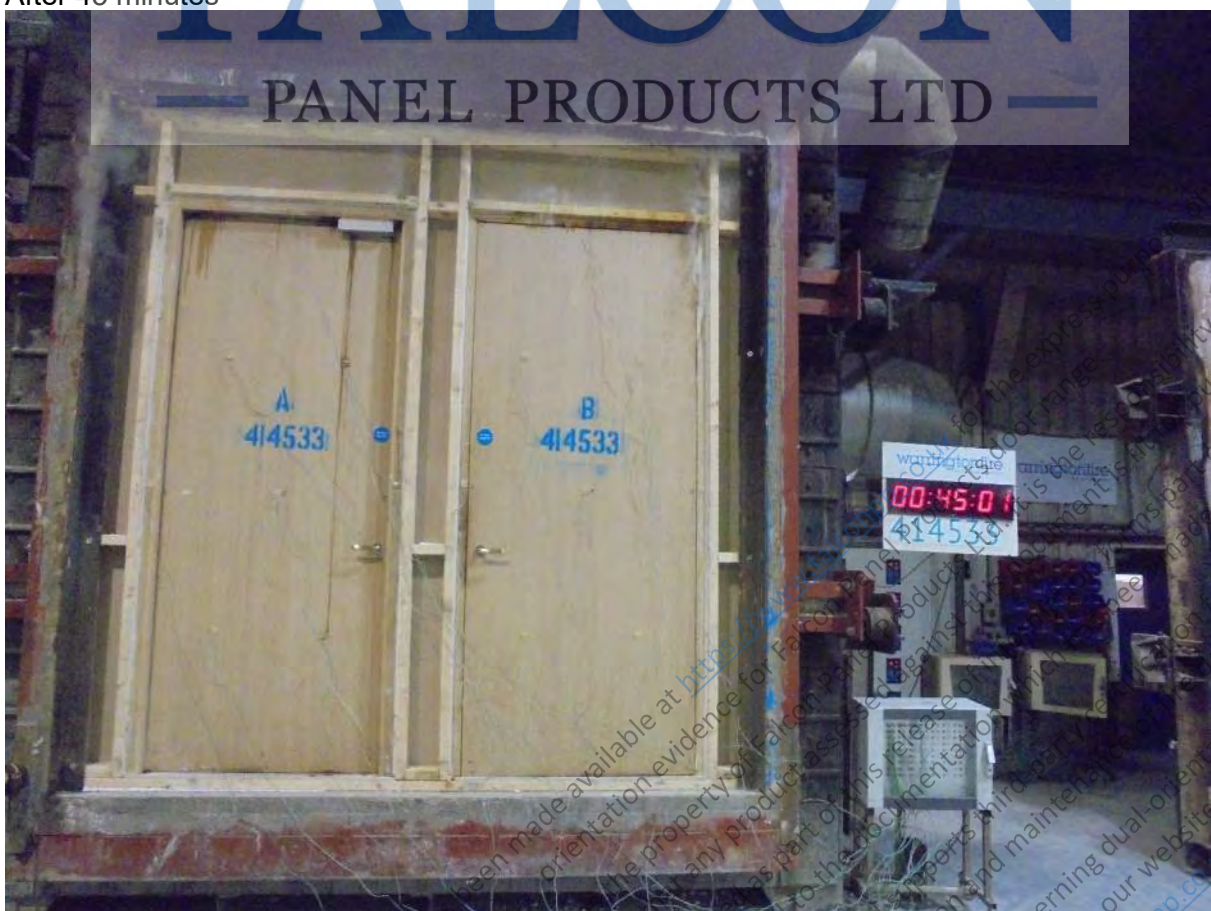
At 60 minutes

60:30 Doorset A, There is a glow visible at the top hanging corner.

67:45 Doorset A, a cotton pad integrity test was performed at the top hanging corner which resulted in the ignition of the cotton pad therefore constituting **integrity failure**.

69:00 Doorset A, There is continuous flaming at the top hanging corner thereby constituting **further integrity failure**.

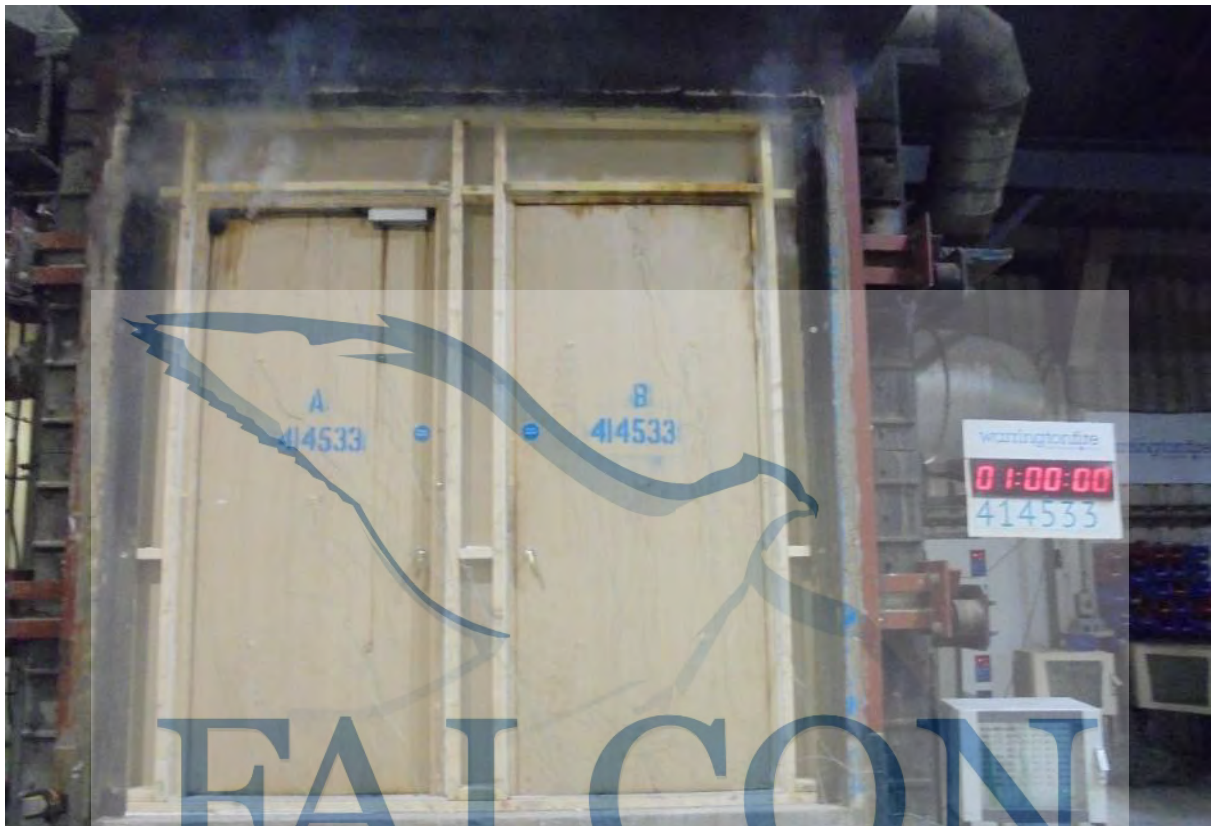
Exposed face – post test

79:30 Doorset A, There is continuous flaming at the bottom closing corner thereby constituting **further integrity failure**.
