The fire resistance performance of two single-leaf, single-acting doorsets, when tested in accordance with BS 476: Parts 20 and 22: 1987

403596

Sealed Tight Solutions

20th August 2018

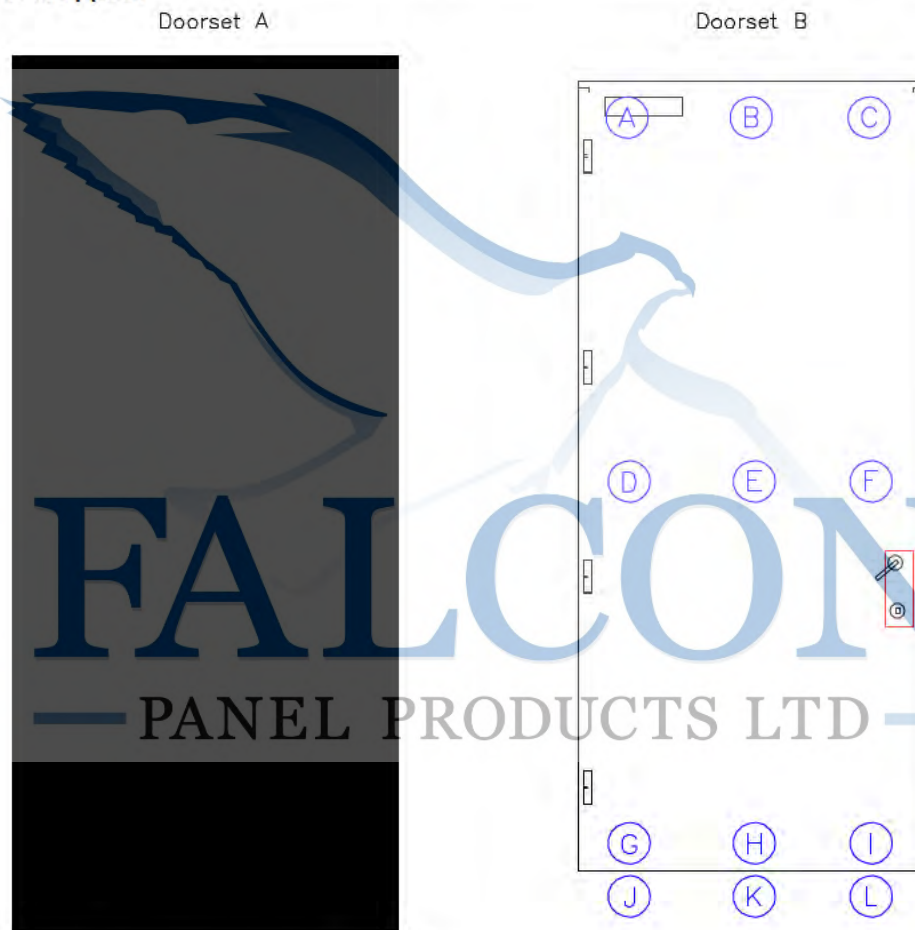
5.3 Door Distortion Data

The following tables show the distortion of the door in mm with an accuracy of ± 1 mm.

A positive measurement indicates distortion towards the furnace.

A negative measurement indicates distortion away from the furnace.

J, K and L give vertical movement of the door, a negative reading indicates that the door has dropped.

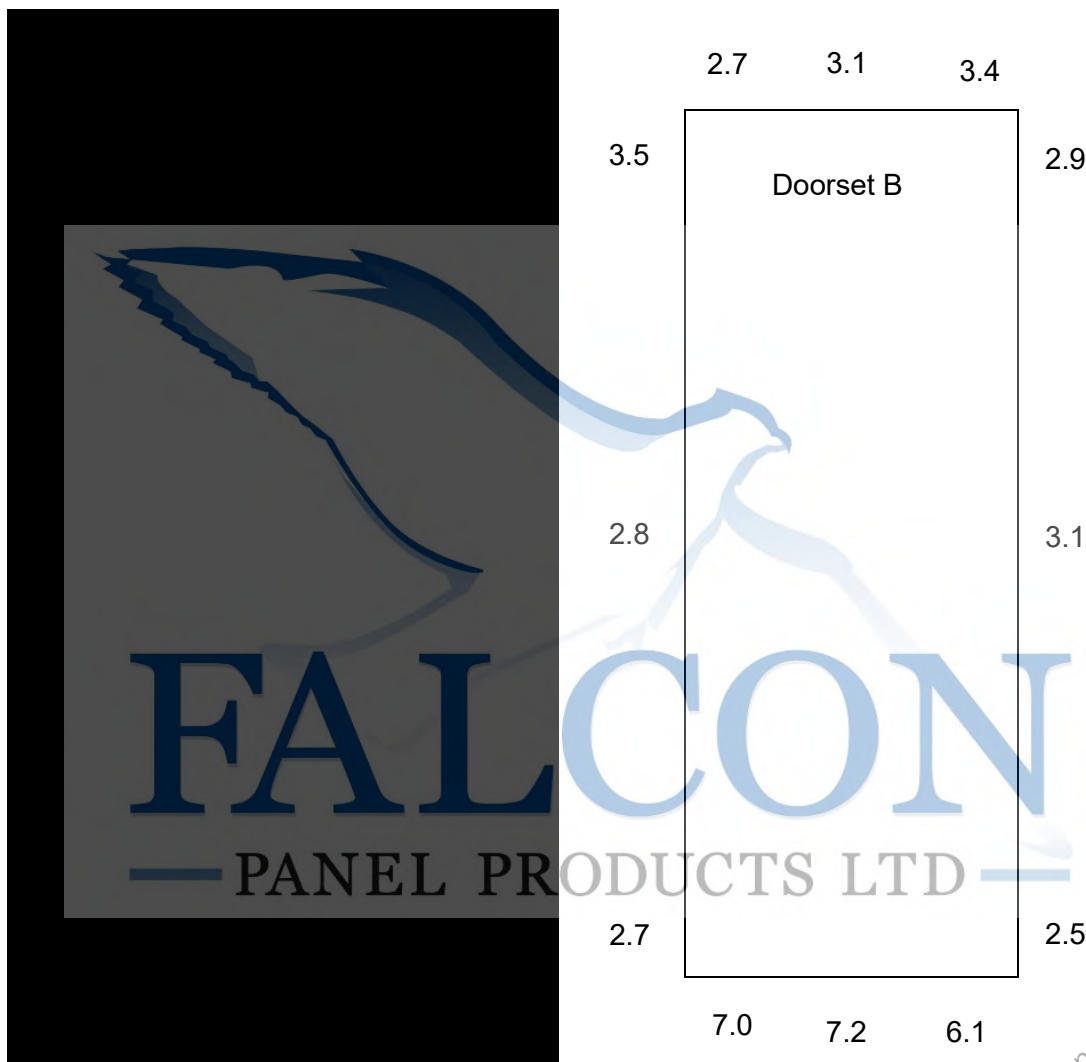
5.4 Door leaf to frame gaps

The gaps between the edge of the door and frame were measured prior to test. A total of 24 readings were taken. The measurements (in mm) are given in Section 5.4 of this report.

Gaps shown

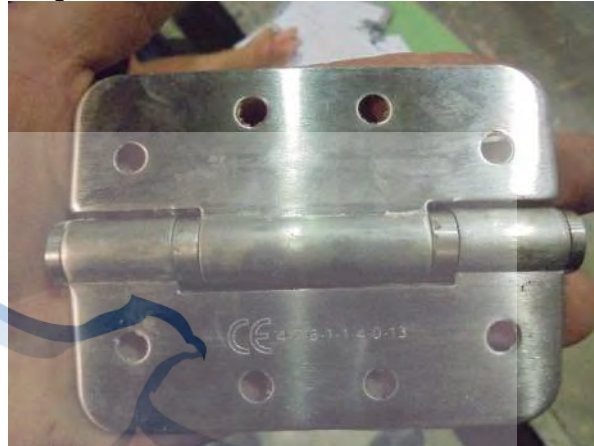
Hinges – both doorsets

Make/type	Size (mm)	Location	Key to figures
Hinges	4No. Jedo 102 bearing butt type hinge – stainless steel construction	102 x 31 x 3 (blade size)*	Fitted 150mm, 800mm, 1445mm and 2095mm from the head of the leaf	11
Closer	Synergy Hardware overhead type closer Ref: s 800 EN 2-5*	260 x 75 (footprint)	Surface fitted on the unexposed face of the leaf as per the manufacturer's instructions	12
Latch – disengaged	Harbrine steel mortice lock/latch with Eurocylinder with thumbturn Ref: Hoppe Arrone AR8100*	235 x 20 (forend size) 235 x 85 x 20 (case size)	Centre of the latch nib fitted 975mm from the bottom edge of the leaf	13
		170 x 25 (keep size)		
Furniture	Harbrine lever type handle and lock escutcheon Ref: Instinct Hardware IH - 1912	Ø50 (rose size)	Fitted appropriate to the lock/latch	14

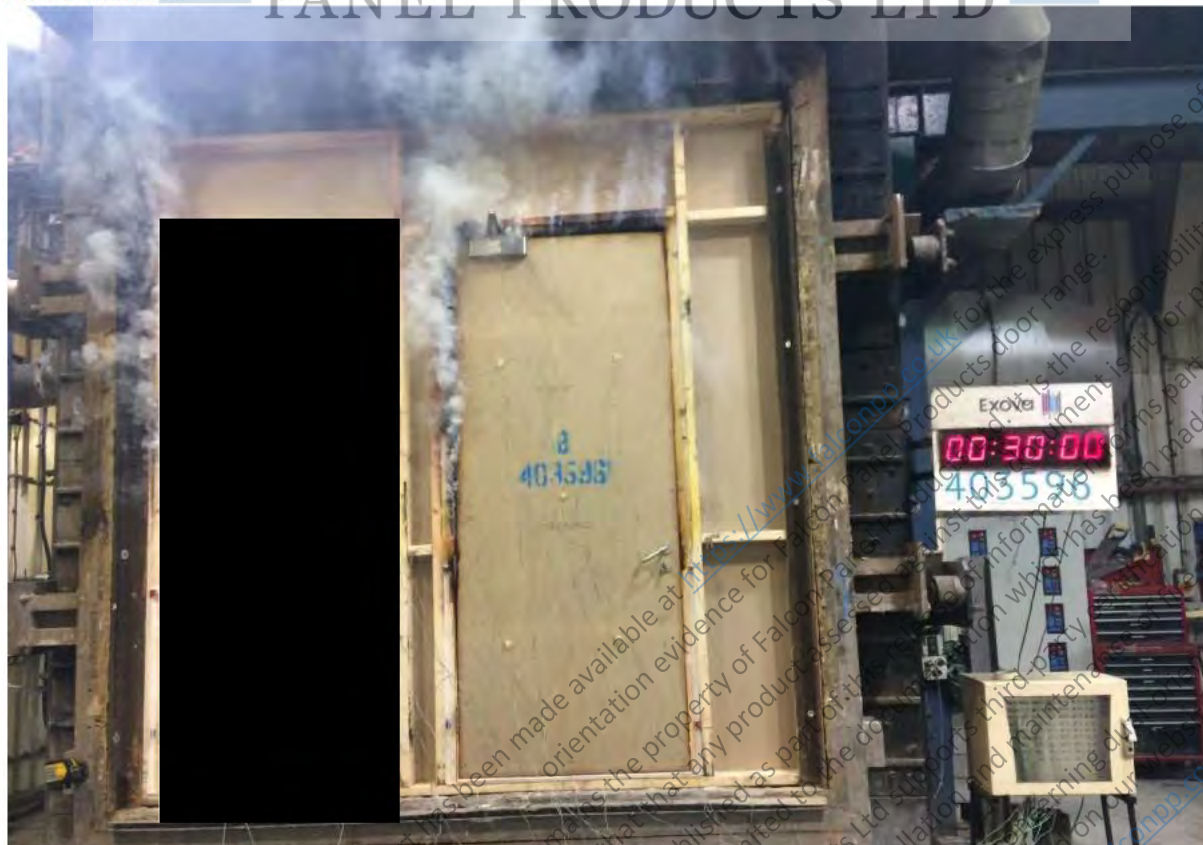
At 30 minutes

30:50	Both doorsets, There is discolouration around the top two hinge positions on both doorsets and the third hinge on doorset B.
34:40	Doorset B, There is a glow visible at the head.

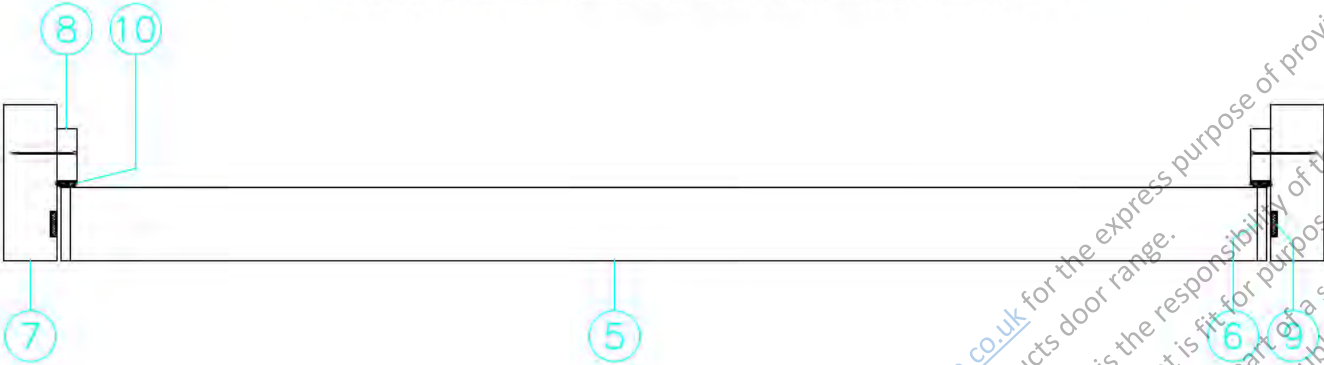
Horizontal cross sections

Species/type	Dimensions (mm)	Density (kg/m ³)	Moisture (% w/w)	Key to figures
Head and jambs	European Redwood*	95 wide x 32 deep	510*	10.9	7
Stop – planted (pinned)	European Redwood*	12 high x 32 wide	510*	10.2	8
Head to jamb jointing detail	Half lap jointed – screwed	-	-	-	-
Frame to supporting construction fire stopping detail	Stone based mineral fibre capped with 10mm deep ST88 intumescent mastic on the both sides	Nominally 10-18 wide x mineral fibre with 10mm ST88 intumescent capping to each face	-	-	-
Frame to supporting construction fixing detail	4No. steel screws per jamb with Broadfix Polypropylene plastic packers fitted to the full depth of the frame at each fixing location*	50 x 100 long fitted at 600 to 800mm centres.*	-	-	-
Architrave	MDF fitted on the exposed face only	45 wide x 18 thick	750**	9.8	-
Threshold	Promat Supalux	9 thick	-	-	-

Make/type	Size (mm)	Location	Key to figures
Leaf edge	None fitted	-	-	-
Frame reveal – head and jambs	Sealed Tight Solutions STS154FO (Fire only)	15 x 4	Fitted centrally in the frame reveal	9
	Sealed Tight Solutions STS1009 acoustic/smoke seal	11 x 5*	Fitted to the upstand of the stop	10

Description of Construction (Refers to Figures 1 to 4 of the Appendix)

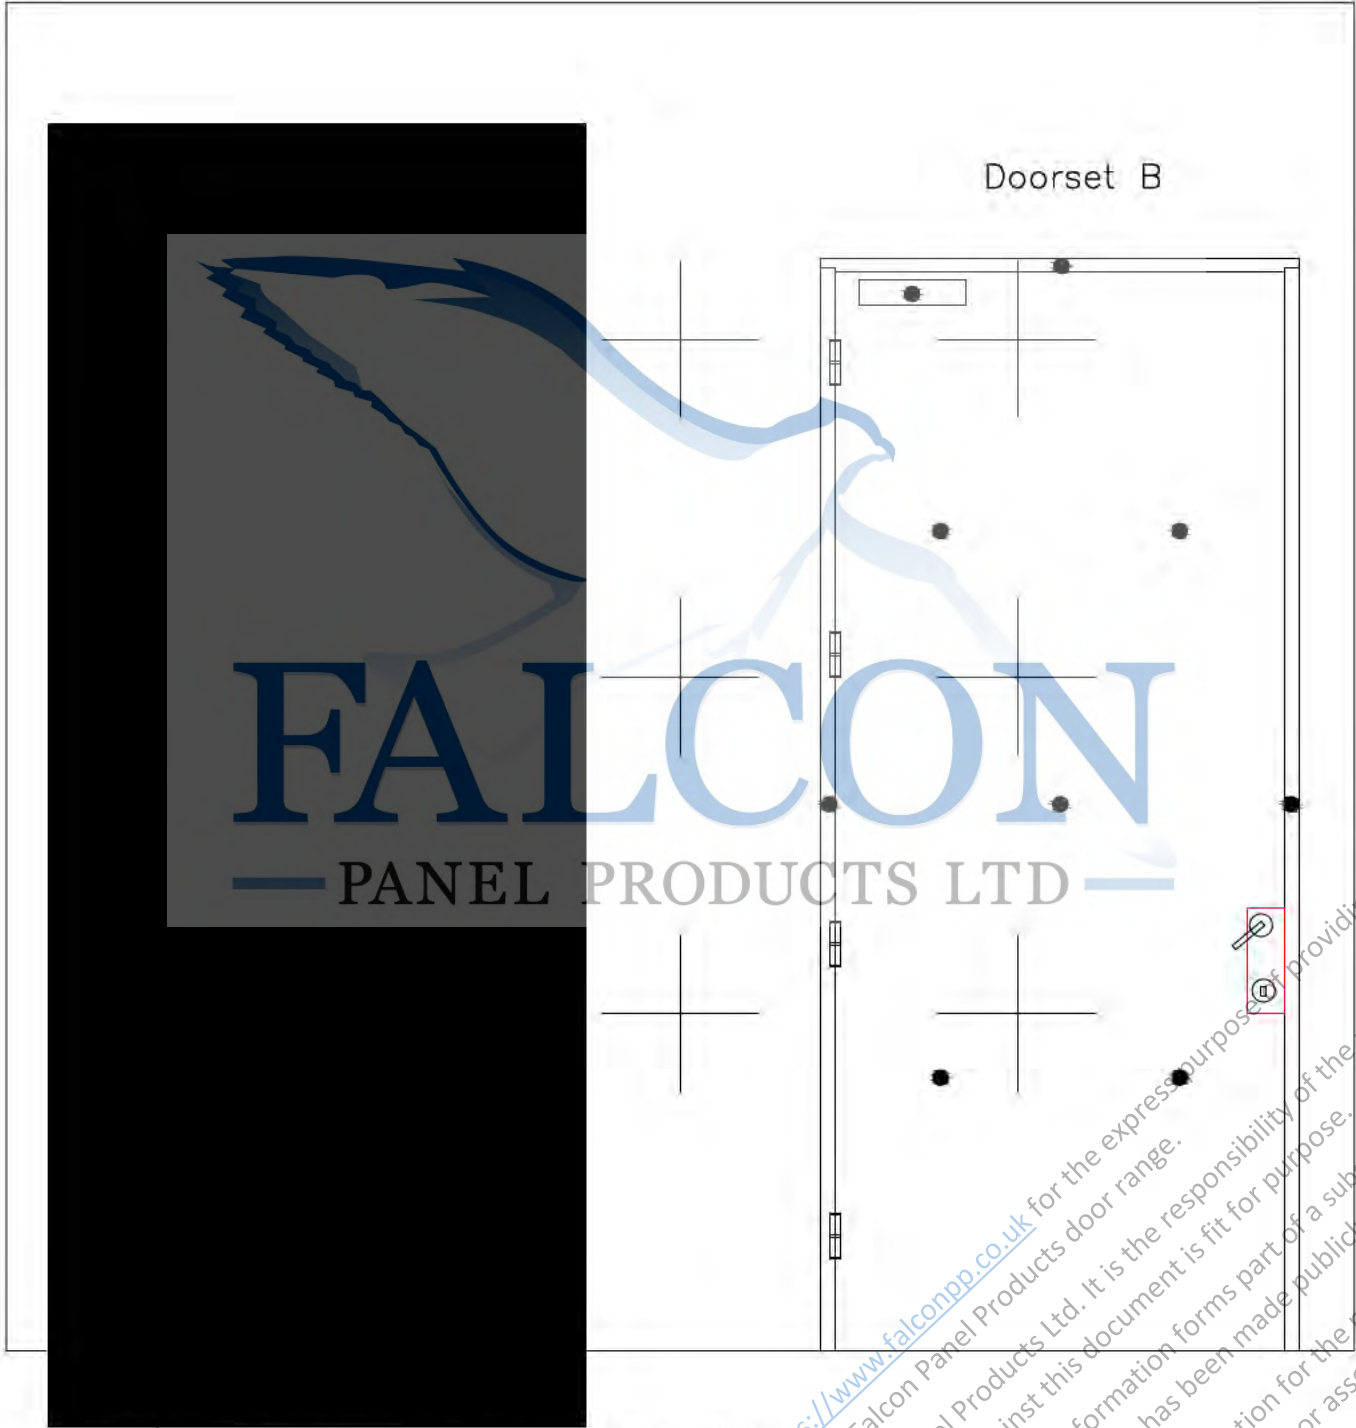
Title Thermocouple positions (All dimensions in mm)		
Date Drawn 24/08/18	Drawn By ARD	Scale NTS
Project No. WF 403596		Appendix

The temperature of the unexposed face of both doorsets was monitored by means of five thermocouples fixed to the surface of the door leaf and three thermocouples attached to the frame, one at midheight on each jamb and one centrally located above the leaf on the frame head, an additional thermocouple was fixed to the closer body.

- ⊕ : Furnace Thermocouples
- : Unexposed Face Thermocouples

Viewed From Unexposed Face

The thermocouple positions are shown in Figure 4 of the appendix. The average temperature of the door leaves and maximum temperature of the doorsets are shown graphically in Section 5.2.
