The fire resistance performance of two single leaf single acting doorsets with glazing when tested in accordance with BS 476: Parts 20 and 22: 1987

405305

Falcon Panel Products Limited

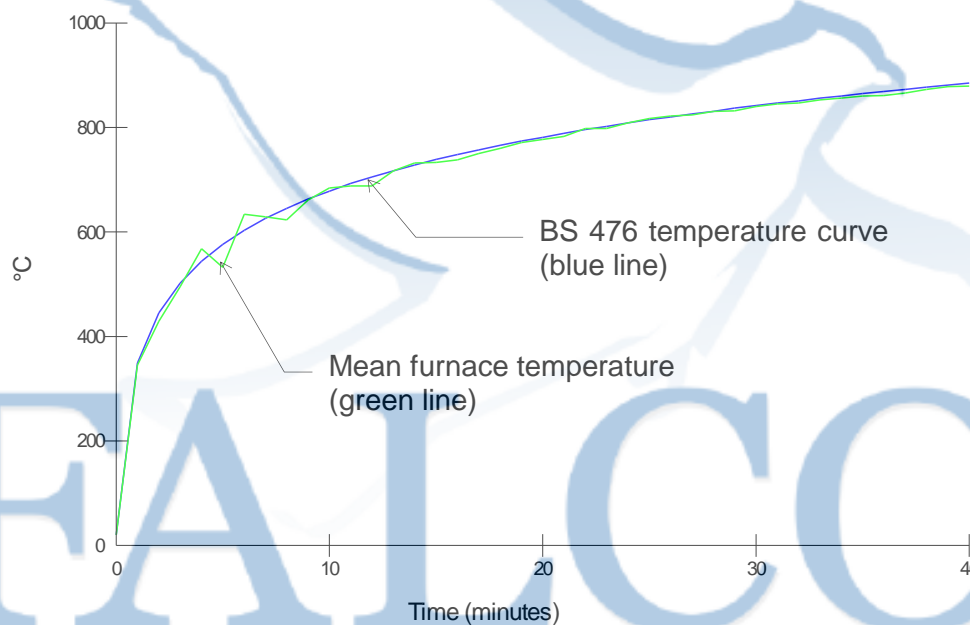
5.1 Furnace Temperature Curve

The furnace was controlled to follow the temperature/time relationship specified in BS 476: Part 20: 1987 as closely as possible, using the average of nine thermocouples suitably distributed within the furnace. The temperatures recorded are shown graphically in Section 5.1.

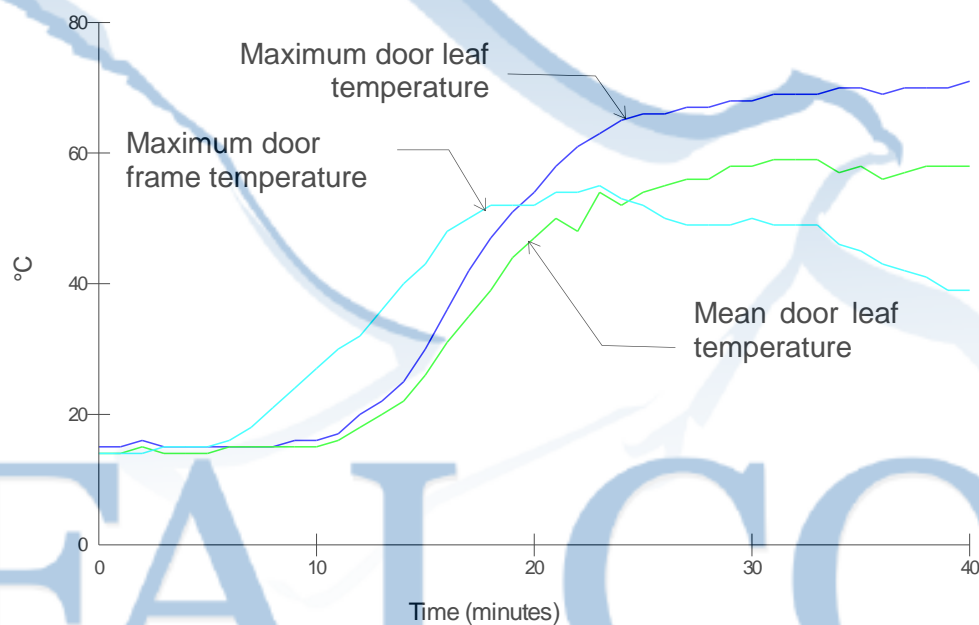
Doorset A

The temperature of the unexposed face of doorset A was monitored by means of five thermocouples fixed to the surface of the door leaf and three thermocouples attached to the doorframe, one at mid height on each jamb and one centrally located on the frame head. Two additional thermocouples fixed to the glass.

The thermocouple positions are shown in Figure 4 of the appendix. The average temperature of the door leaves and maximum temperature of the doorsets are shown graphically in Section 5.2.

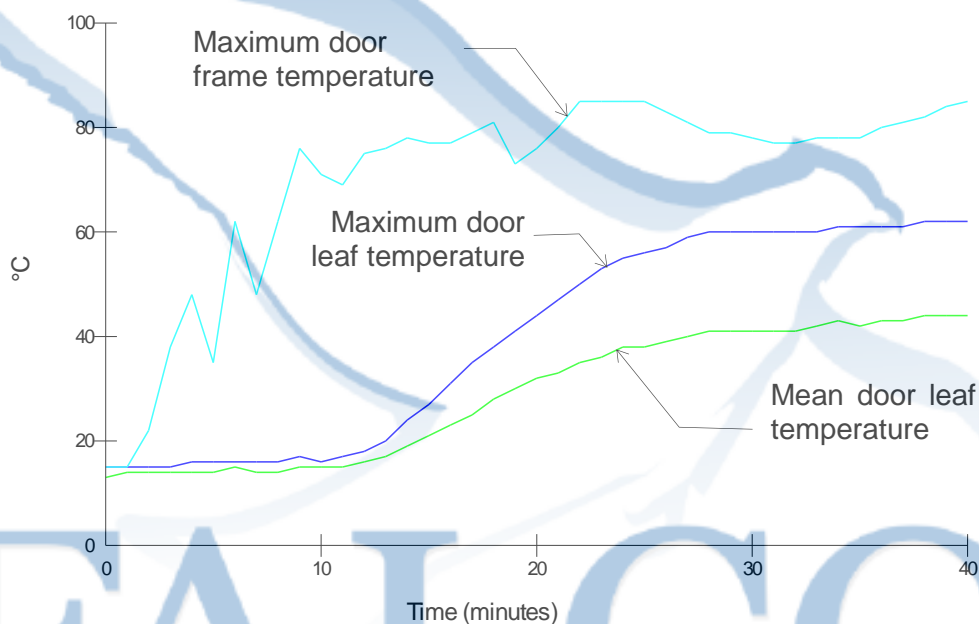
Doorset B

The temperature of the unexposed face of doorset B was monitored by means of five thermocouples fixed to the surface of the door leaf and three thermocouples attached to the doorframe, one at mid height on each jamb and one centrally located on the frame head. Two additional thermocouples fixed to the glass and one additional thermocouple was fixed to the door closer.

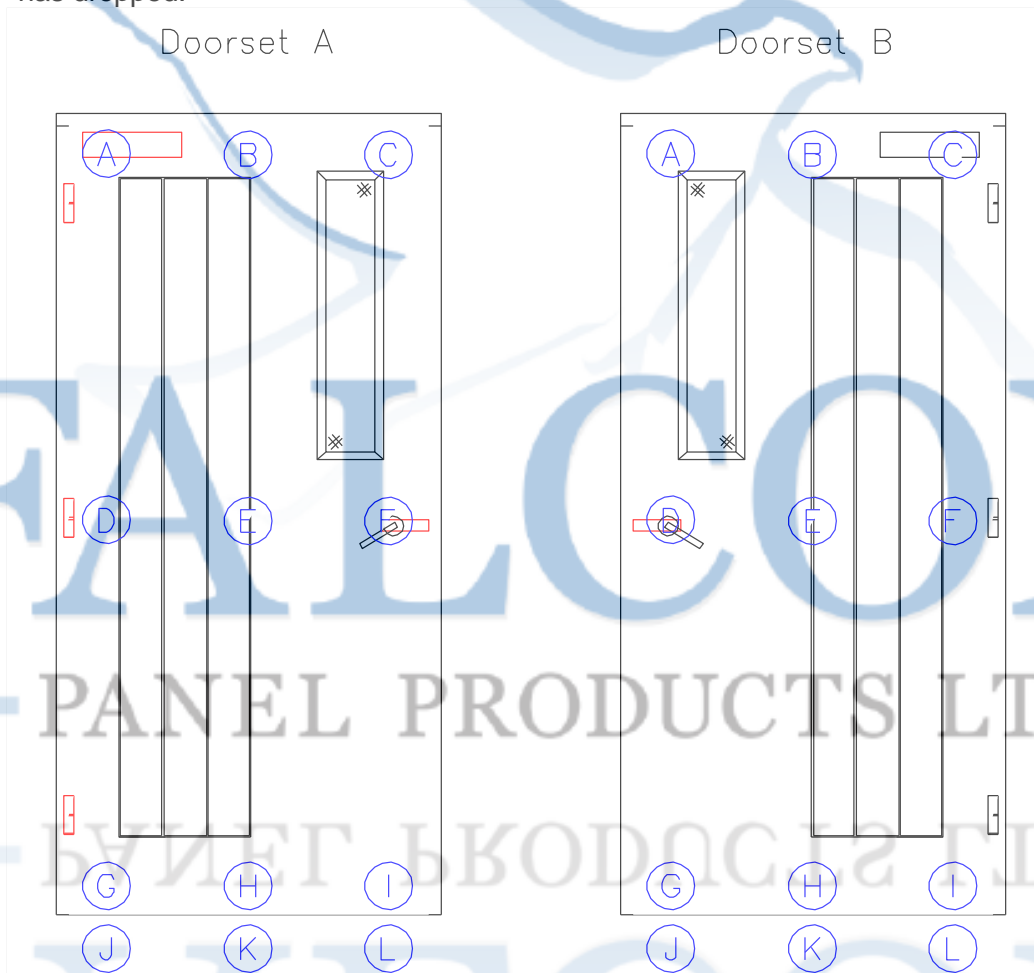
5.3 Leaf Distortion Data

The following tables show the distortion of the door in mm with an accuracy of ± 1 mm.

A positive measurement indicates distortion towards the furnace.

A negative measurement indicates distortion away from the furnace.

J, K and L give vertical movement of the door, a negative reading indicates that the door has dropped.

Doorset A - leaf (hung on the left and opening in towards the furnace)

Time	A	B	C	D	E	F	G	H	I	J	K	L
10	-1	0	1	-9	-6	-3	-14	11	2	-1	0	-1
20	-1	-4	10	-7	-23	-7	-13	-9	6	0	-1	-1
30	0	-4	14	-10	-35	-7	-3	-5	7	-1	-1	-1

Doorset B - leaf (hung on the right and opening out away from the furnace)

Time	A	B	C	D	E	F	G	H	I	J	K	L
10	-2	-5	-1	-11	-12	-5	-4	-9	-3	-1	-2	0
20	2	-6	-1	1	-30	-8	3	-6	2	-1	-2	0
30	2	-6	0	5	-43	-5	8	-4	2	0	-2	-1

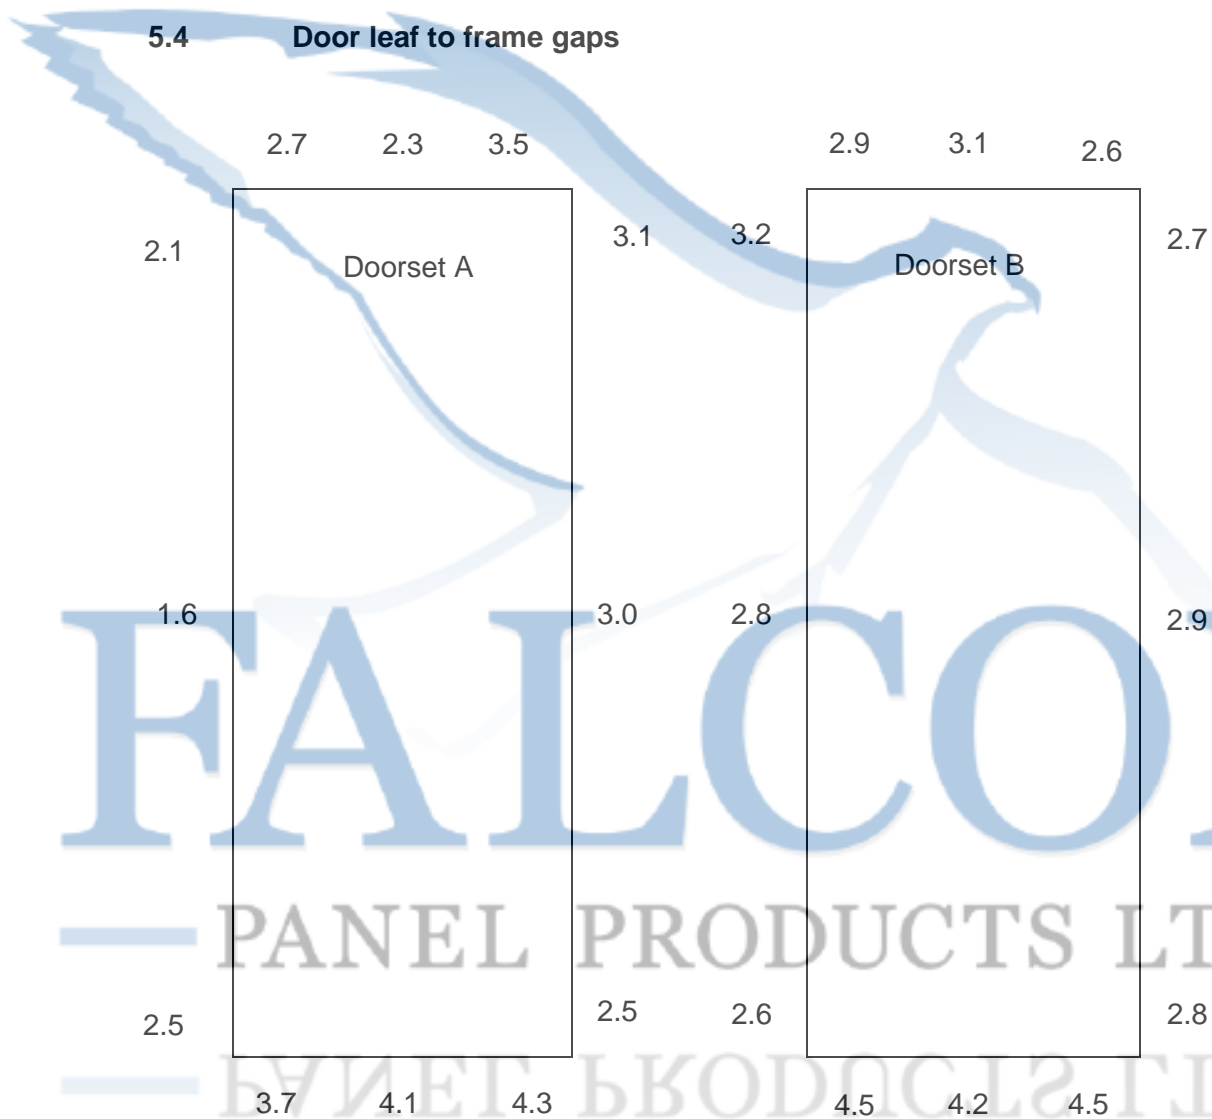
Gaps shown

The gaps between the edge of the door and frame were measured prior to test. A total of 24 readings were taken. The measurements (in mm) are given in Section 5.4 of the report.

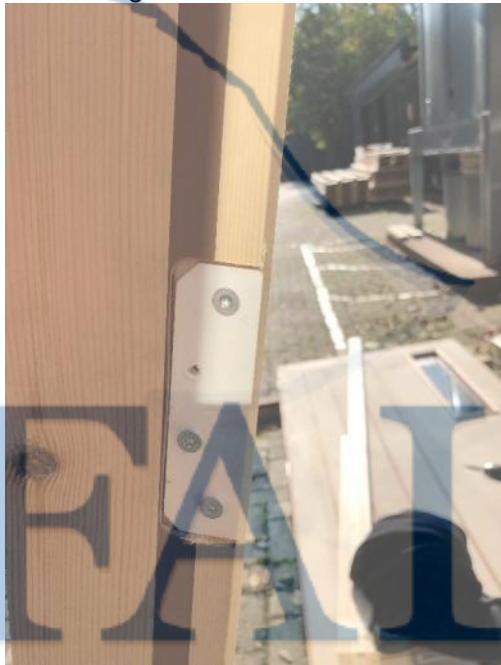
Around hinge blade and intumescent under hinge blades – both doorsets

Make/type	Size (mm)	Location
Around hinge blade	Fully interrupted	-	Hinge blade fully interrupts seal in frame reveal
Under hinge blades	Lorient Polyproducts Ltd MAP*	1 thick	Fitted under the hinge blade on frame
Encasing latch body	Lorient Polyproducts Ltd MAP*	1 thick	Fitted around the body of the latch
Under latch forend	Lorient Polyproducts Ltd MAP*	1 thick	Fitted under the latch forend
Around latch keep	Fully interrupted	-	Latch keep fully interrupts seal in frame reveal
Under latch keep	Lorient Polyproducts Ltd MAP*	1 thick	Fitted under the latch keep

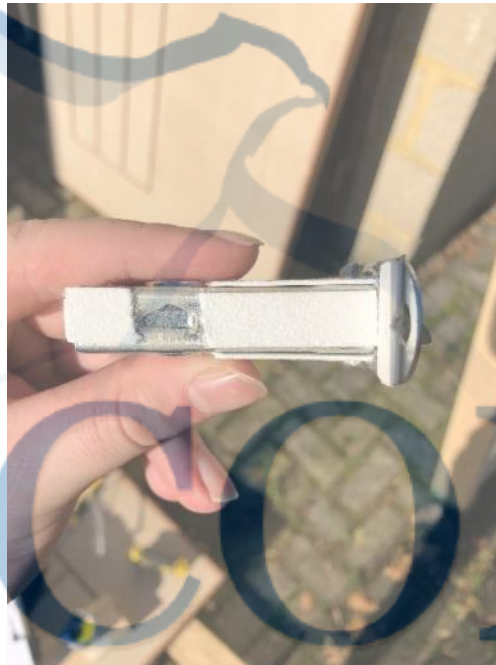
Intumescent fitted to latch body – both doorsets

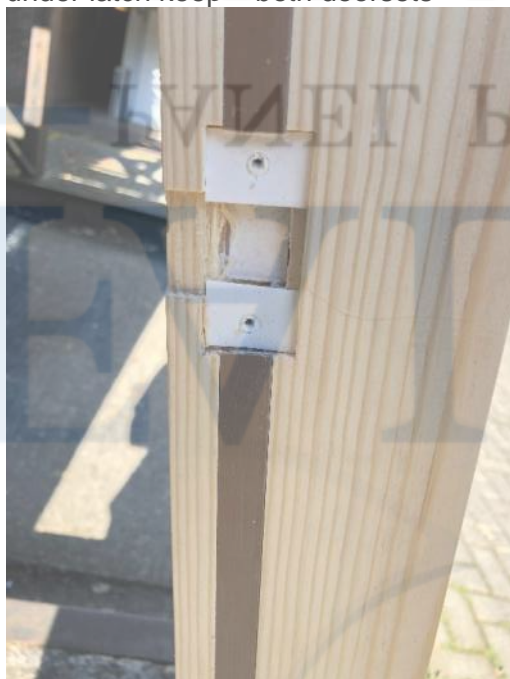
Around latch keep and intumescent under latch keep – both doorsets

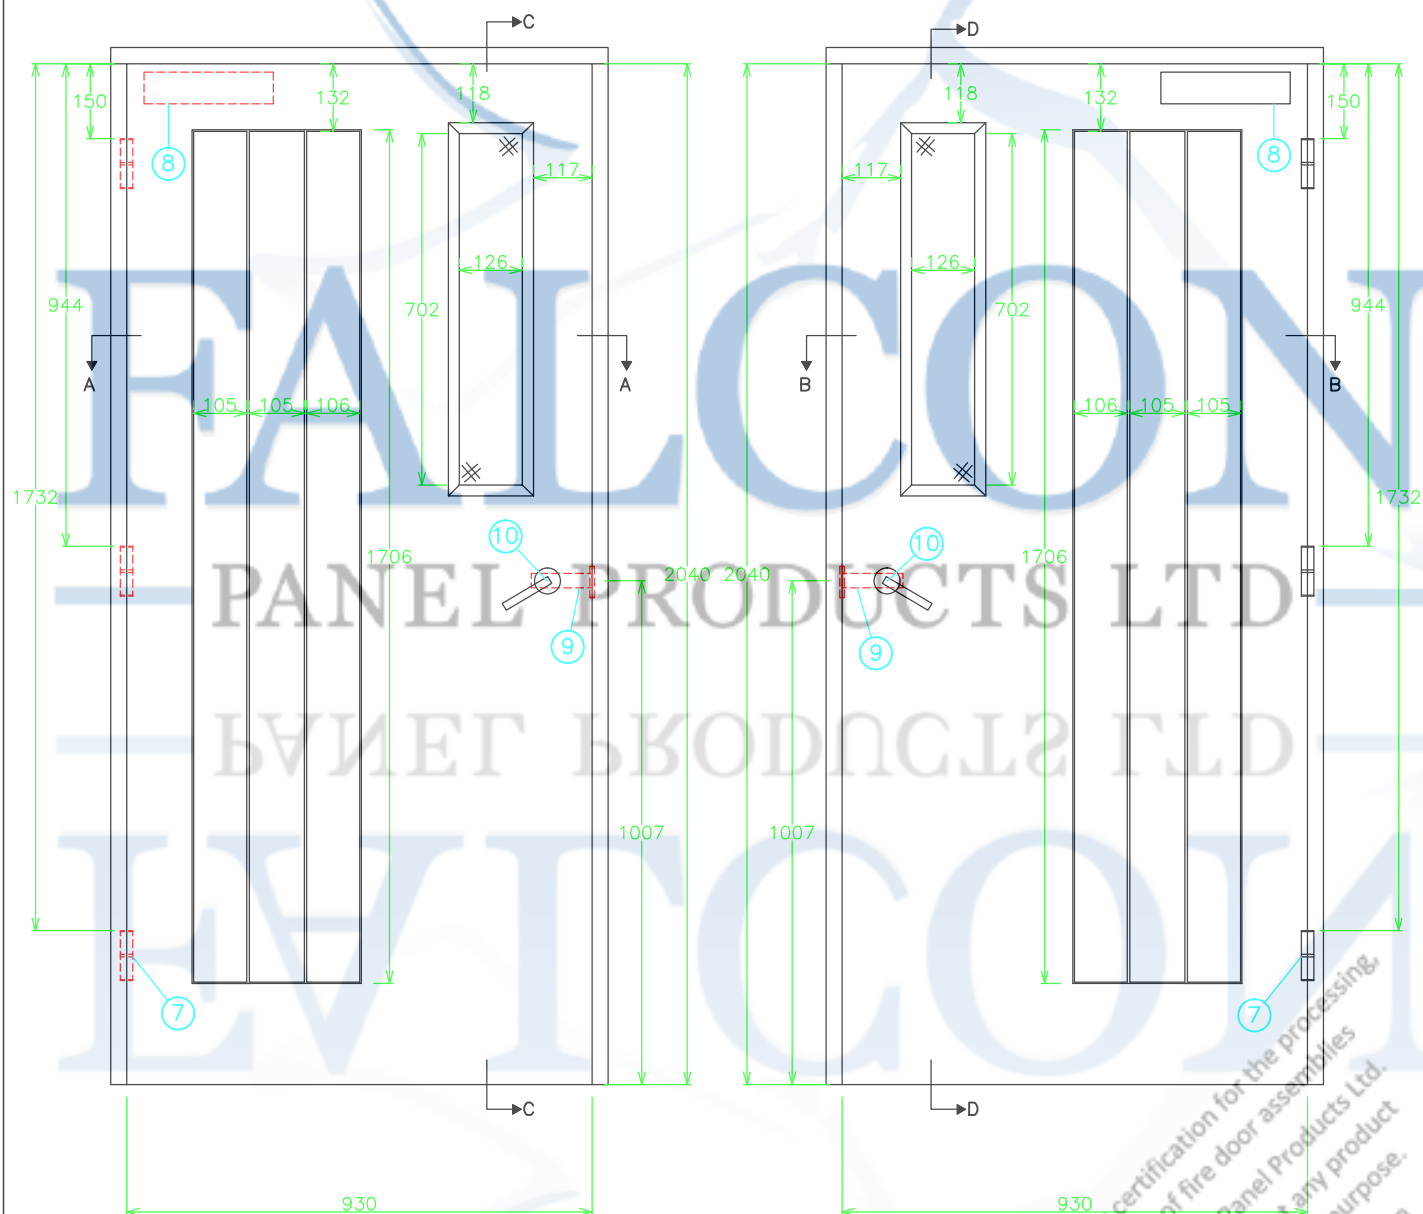
Unexposed face elevation
showing hardware positions
(All dimensions in mm)

Make/type	Size (mm)	Location	Key to figures
Hinges	3No. Eurospec Enduromax stainless steel bearing butt hinges*	100 x 30 x 3 (blade size)	Fitted 150mm, 944mm and 1732mm from the head of the leaf	7
Closer	Rutland TS.9205 overhead type closer	236 x 55 (footprint)	Surface fitted as per the manufacturer's instructions on the exposed face of doorset A and the unexposed face of doorset B	8
Latch	ERA tubular steel latch reference: 1880-95 CE tubular latch*	55 x 25 (forend size) 55 x 20 x 60 (case size)	Latch nib fitted 1007mm from the bottom of the leaf	9
Furniture	Stanza Stainless steel lever type handle reference: ZPZ090SC*	Ø 52 (rose size)	Fitted appropriate to the latch	10

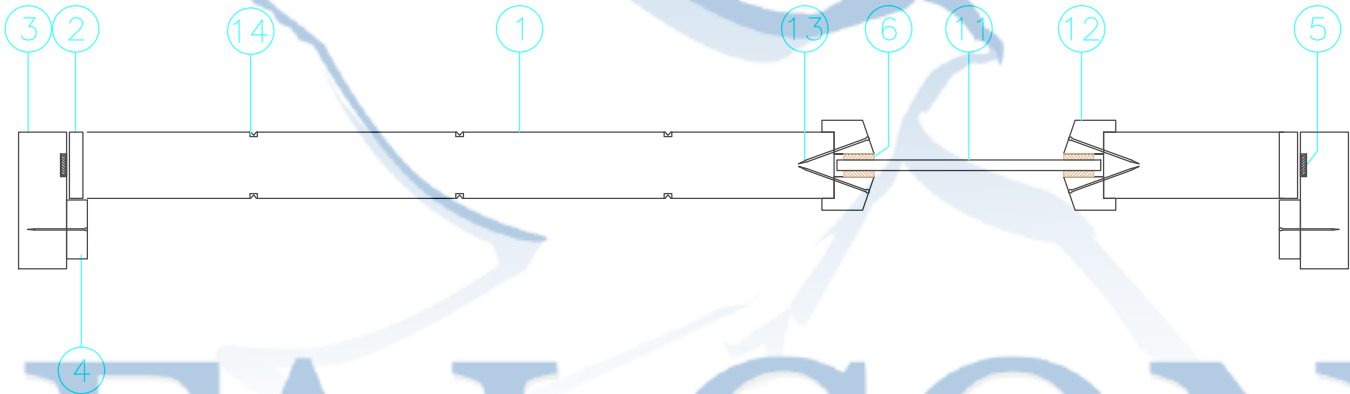
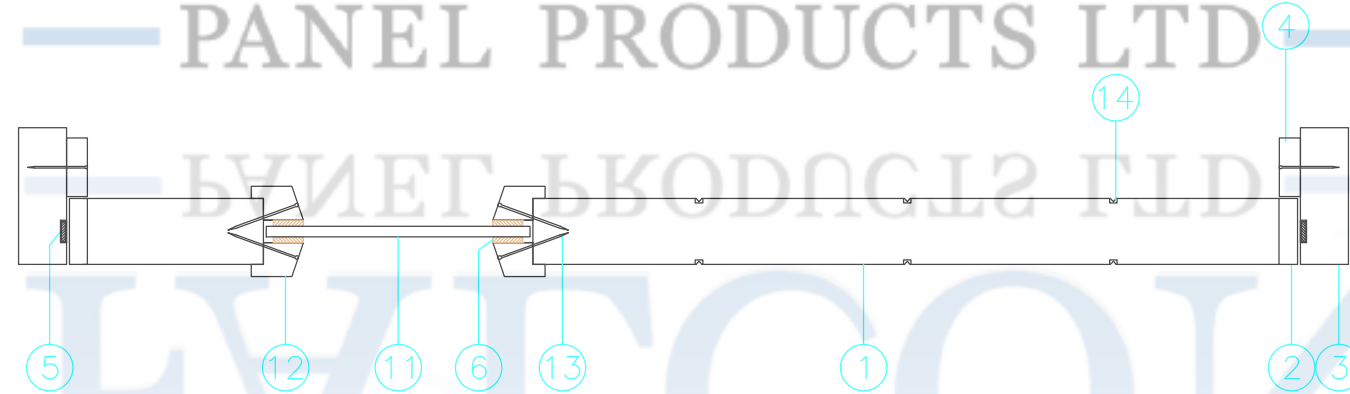
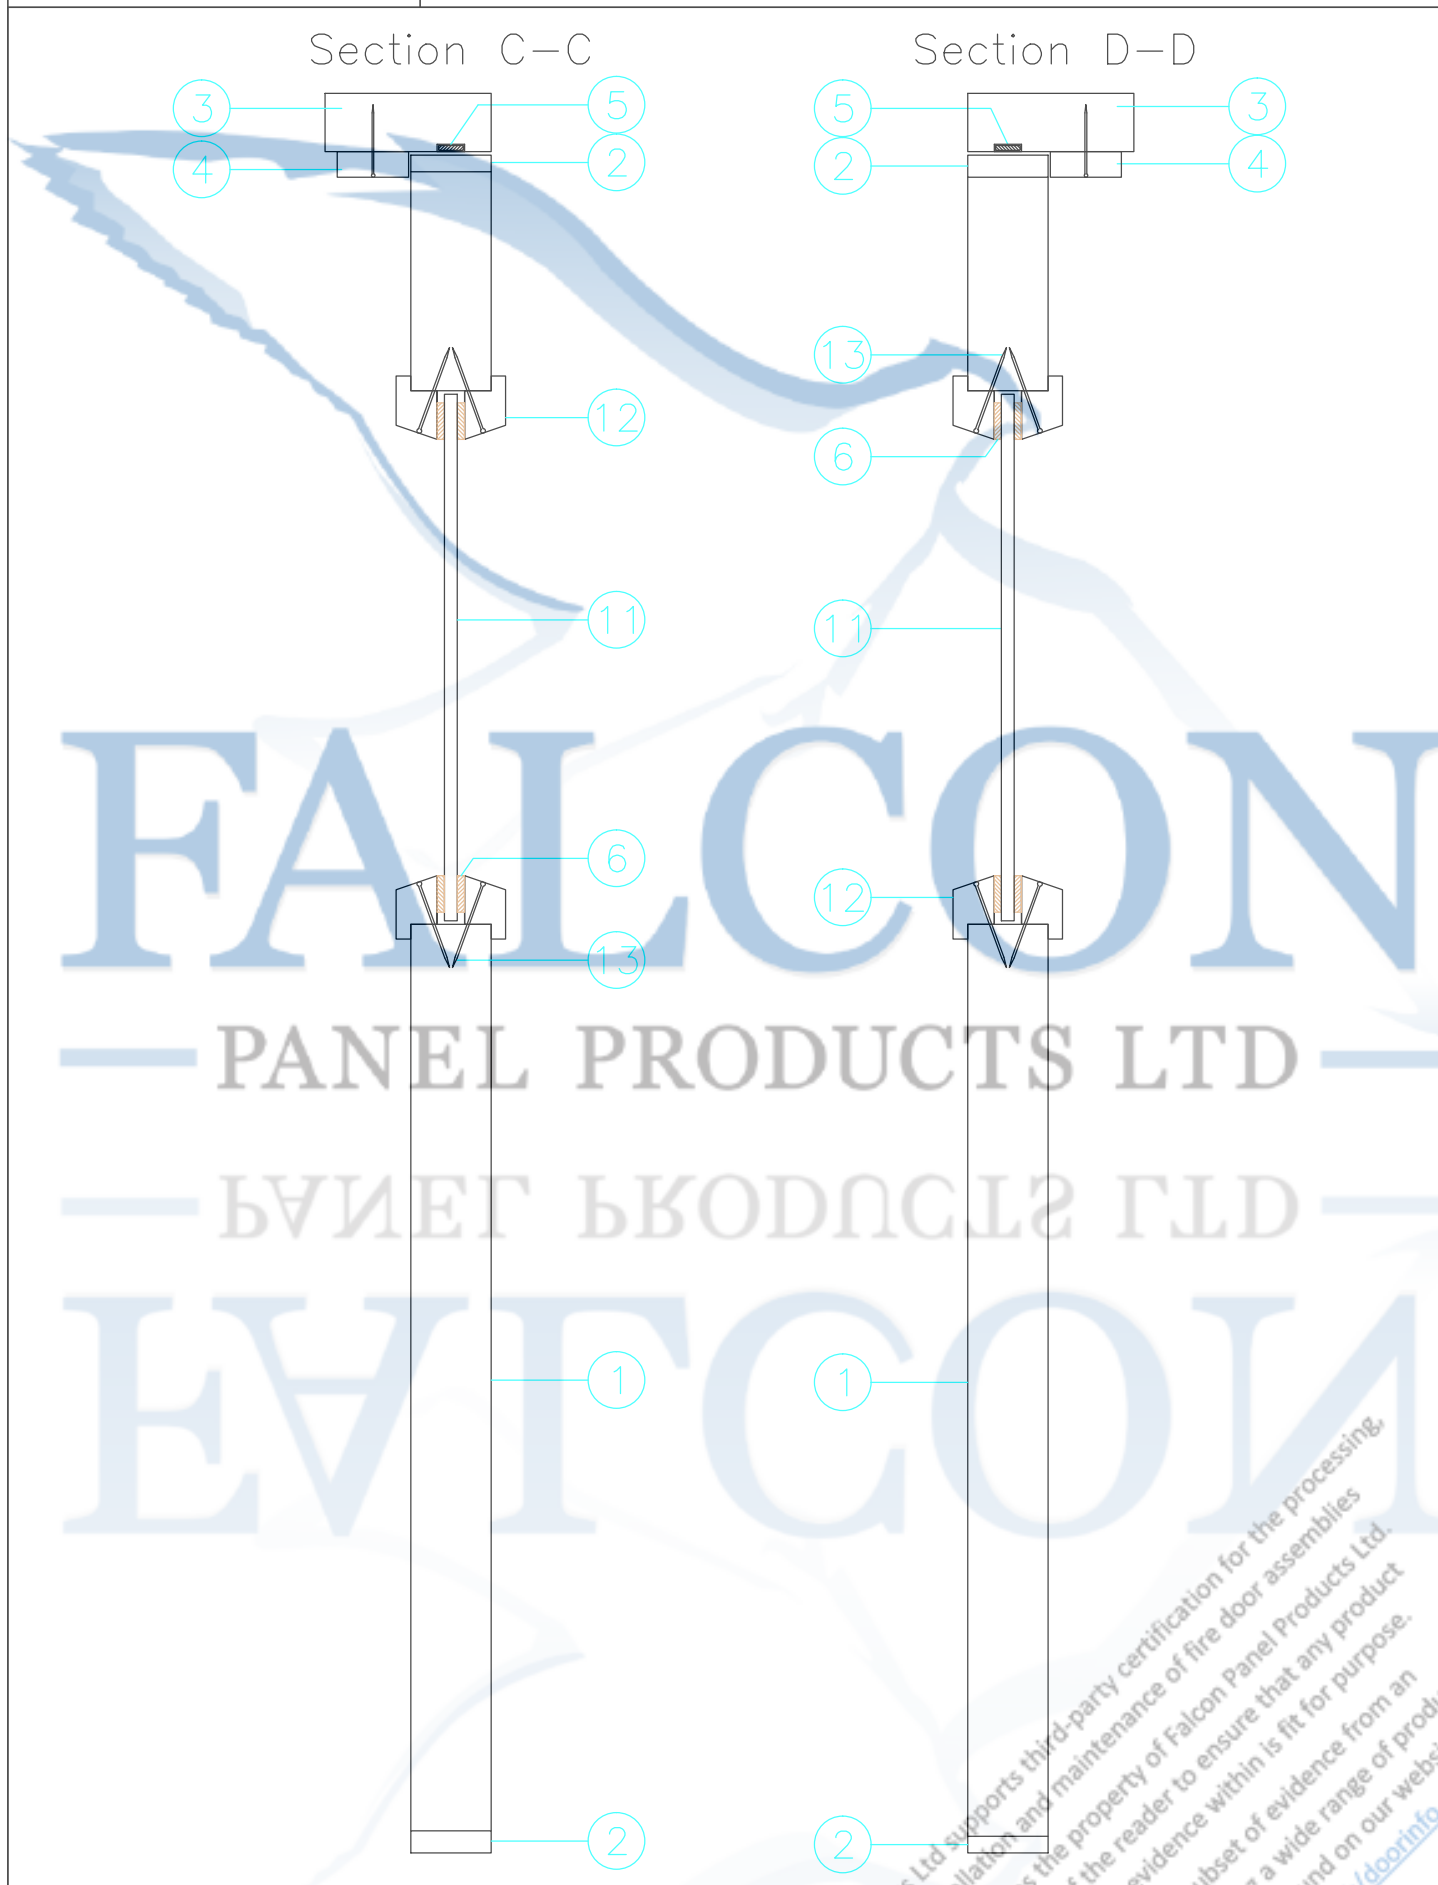
Section A-A

Section B-B

Vertical cross-sections
(All dimensions in mm)

Species/type	Dimensions (mm)	Density (kg/m ³)	Moisture (% w/w)	Key to figures
Stiles and rails	None fitted	-	-	-	-
Core	Falcon Panel Products Ltd Strebord particleboard*	44 thick	630-635*	10.9-11.2	1
Facings	None fitted	-	-	-	-
Decorative inlay	Sapele*	10 wide x 10 deep with a 6 wide x 6 deep triangular groove Fitted within a 10mm deep x 10mm wide groove within the face of the leaf*	640**	-	14
Adhesive	Lippings	Caberfix D4 Polyurethane*	-	-	-
	Decorative Inlay	Gorilla Wood Glue PVA*	-	-	-
Lippings – all edges	Sapele*	9 thick	640**	9.7-9.9	2

Species/type	Dimensions (mm)	Density (kg/m³)	Moisture (% w/w)	Key to figures
Head and jambs	European Redwood	32 wide x 91 deep	510**	7.3	3
Stop – planted (pinned)	European Redwood	39 deep x 14 wide	510**	7.4-7.5	4
Head to jamb jointing detail	Half lapped (screwed)	-	-	-	-
Frame to supporting construction fire stopping detail	Rock mineral wool for full depth of frame capped with acrylic intumescent mastic on the fire side.	Nominally 7.3 -20 wide x 10 deep (mastic size)	-	-	-
Frame to supporting construction fixing detail	4No. screws per jamb fitted at no more than 600mm centres	5Ø x 100 long	-	-	-
Architrave	European Redwood fitted on the exposed face only	45 wide x 18 thick	510**	7.1-7.2	-
Threshold	Non combustible	-	-	-	-

Make/type	Size (mm)	Location	Key to figures
Leaf edge	None fitted	-	-	-
Frame reveal – head and jambs	Lorient Polyproducts Ltd LP1504*	15 x 4	Fitted 14mm from the opening face in the frame reveal	5
Glazing perimeter	Lorient Polyproducts Ltd System-36/7 PLUS LG1513 Plus*	15 high x 13 wide x 2.6 thick U channel*	Fitted encasing the whole perimeter of the glass	6

Make/type	Size (mm)	Location	Key to figures
Glass type	Pyroguard EW30*	7.2 thick*	Fitted 118mm from the leaf head, 117mm from the leaf closing edge	11
Aperture size	-	732 high x 156 wide*	-	-
Sight size	-	702 high x 126 wide	-	-
Glass size	-	726 high x 150 wide*	-	-
Expansion allowance	-	3 all-round	-	-
Beading	Sapele (640kg/m ³ nominal density, 10.9-12.1% mc)	21 high x 25 deep including an 6 x 6 bolection return and a 15° chamfer*	Fitted around the glazing perimeter on both faces	12
Beading fixings	Pneumatically fired steel pins	50 long*	Fitted 50mm from corners at 130mm centres at 30° to the face of the glass*	13

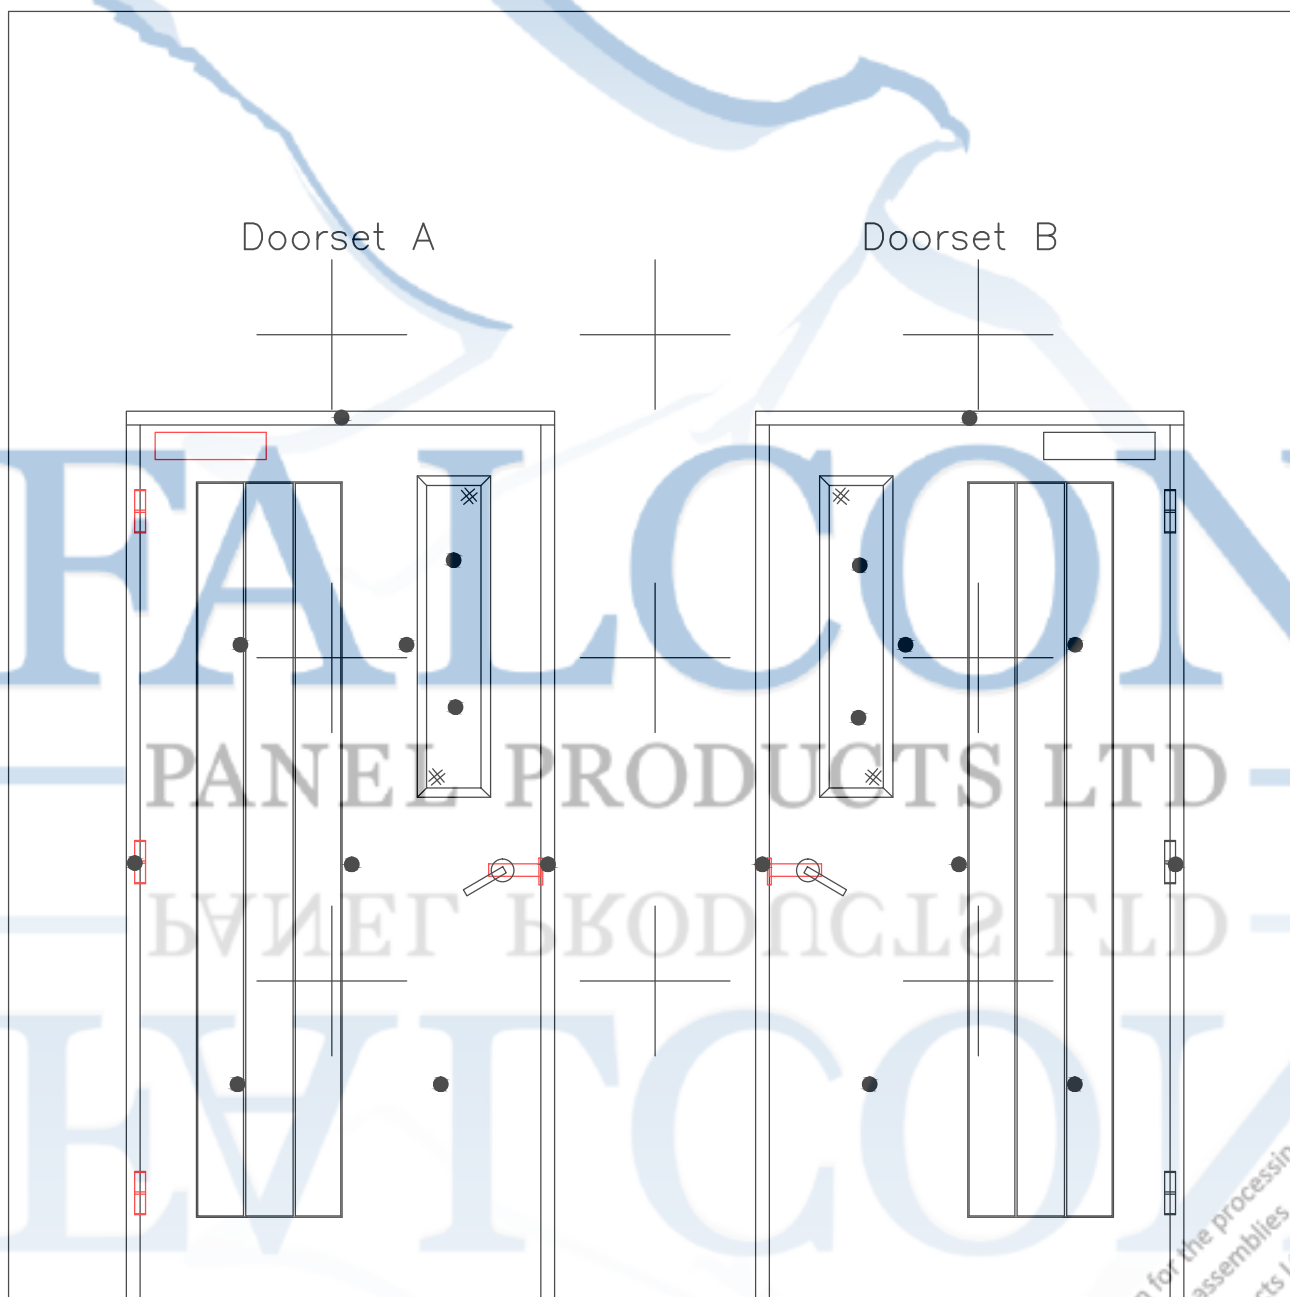
✚ : Furnace Thermocouples
● : Unexposed Face Thermocouples

Viewed From Unexposed Face

Title Thermocouple positions and
leaf/frame gaps
(All dimensions in mm)
