The fire resistance performance of a two single leaf, single-acting doorsets, when tested in accordance with BS 476: Parts 20 and 22: 1987

414162

**Falcon Panel Products Ltd**

14<sup>th</sup> May 2019

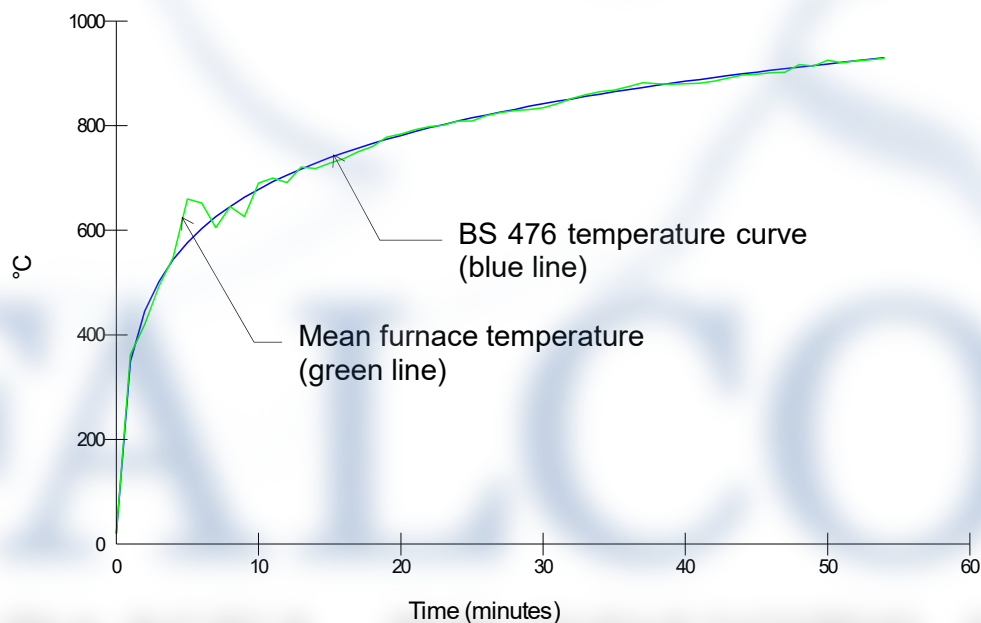
### 5.1 Furnace Temperature Curve

The furnace was controlled to follow the temperature/time relationship specified in BS 476: Part 20: 1987 as closely as possible, using the average of nine thermocouples suitably distributed within the furnace. The temperatures recorded are shown graphically in Section 5.1.

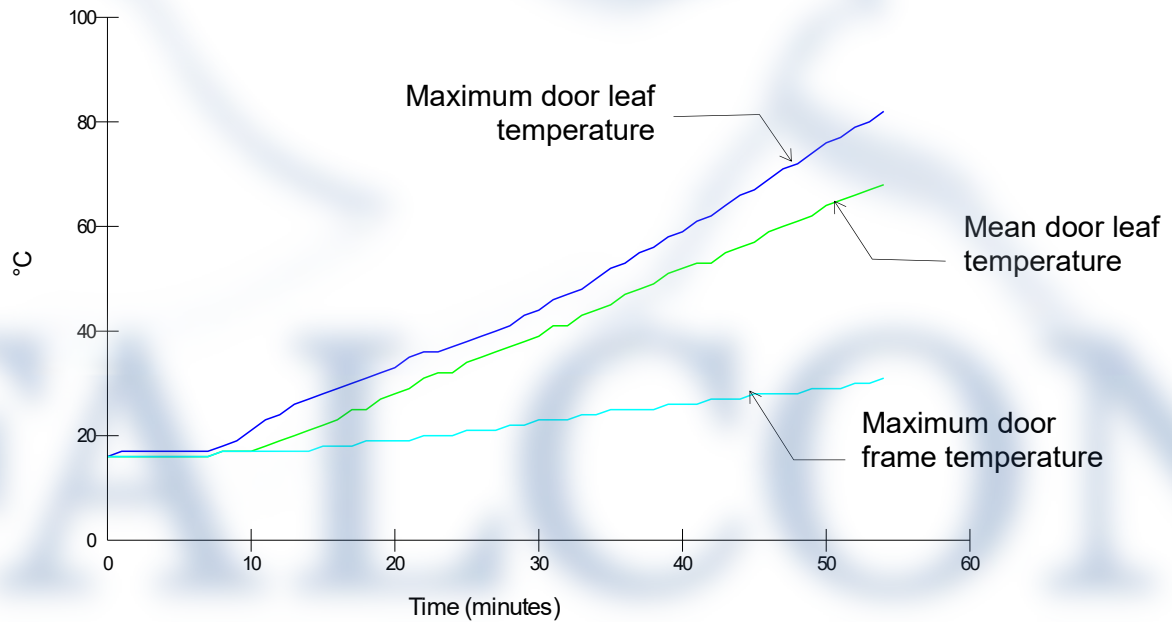
### Doorset A

The temperature of the unexposed face of both doorsets was monitored by means of five thermocouples fixed to the surface of the door leaf and three thermocouples attached to the door frame, one at mid height on each jamb and one centrally located above the leaf on the frame head. The temperature of the letter plate was monitored by one thermocouple attached to the letter plate and one thermocouple fixed to the door leaf 25mm from the letter plate.

## 5.2 Unexposed Face Temperature Curves

The thermocouple positions are shown in Figure 4 of the appendix. The average temperature of the door leaves and maximum temperature of the doorset are shown graphically in Section 5.2.

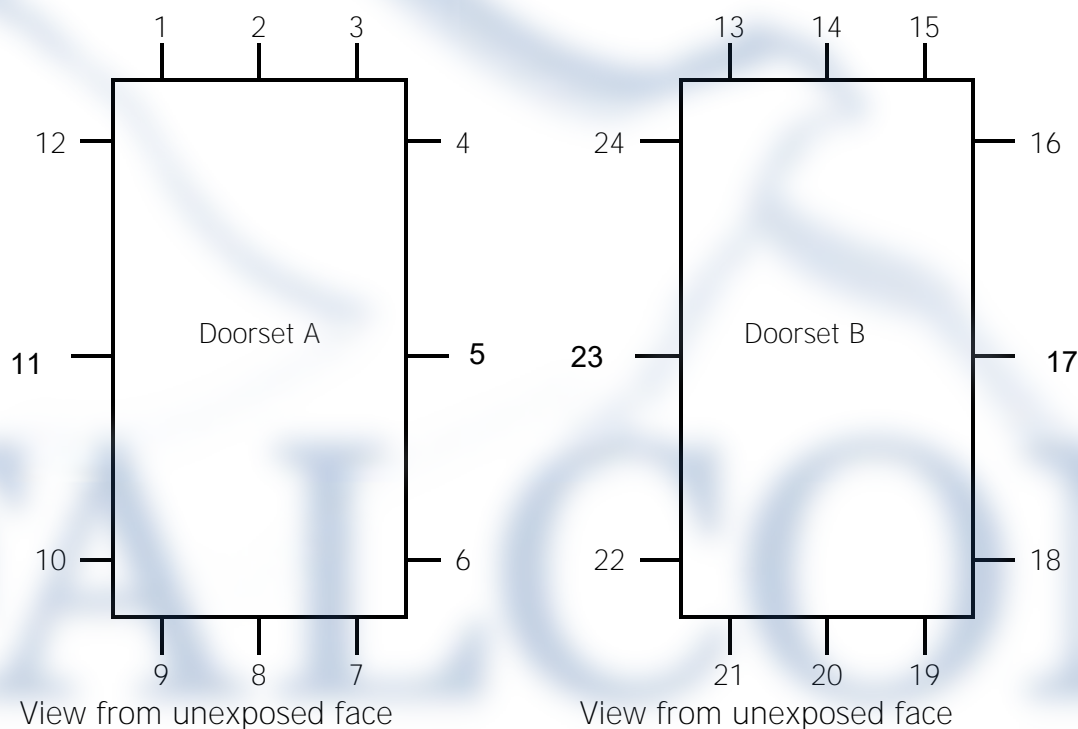
#### 5.4 Door leaf to frame gaps

Door Ref	Gap Dimension in mm at Positions											
A	1	2	3	4	5	6	7*	8*	9*	10	11	12
	3.1	3.1	3.0	3.1	3.2	3.3	2.3	2.2	2.1	3.1	3.0	3.3
B	13	14	15	16	17	18	19*	20*	21*	22	23	24
	2.6	2.7	3.0	3.0	2.8	2.9	2.2	2.1	2.0	3.1	3.0	3.2

Door Ref	Gap Between Face of Leaf and Doorstop in mm at Position											
A	1	2	3	4	5	6	7	8	9	10	11	12
	3.0	2.7	2.9	3.0	2.9	3.0	-	-	-	3.0	3.3	3.4
B	13	14	15	16	17	18	19	20	21	22	23	24
	2.5	2.5	2.5	2.5	2.7	2.9	-	-	-	2.5	2.5	2.5

Door Ref	Gap Between Doorframe and Supporting construction in mm at Position											
A	1	2	3	4	5	6	7	8	9	10	11	12
	10.0	9.0	9.0	9.0	10.0	11.0	-	-	-	10.0	10.0	12.0
B	13	14	15	16	17	18	19	20	21	22	23	24
	9.0	8.0	9.0	9.0	9.0	10.0	-	-	-	10.0	12.0	10.0

The gaps between the edge of the door and frame were measured prior to test. A total of 24 readings were taken. The measurements (in mm) are given in Section 5.4 of the report.

The results of this test were obtained using the specimens provided for testing, and the door to frame gaps recorded in Section 5.4 of this report. Further, where information in relation to the specimen has been provided to us but not verified by us, we have assumed that it is correct; and where comments above identify particular materials or substances comprised in the specimen those comments are based on information supplied to us and/or on general visual inspection undertaken during the process of testing of the sample, and in either case have not been verified by reference to materials testing or documentary evidence except as described above. The fire resistance performance of doors of this design may be different if any aspect of the design or construction differs from that tested. This includes, by way of example only, any difference as a result of (i) any deviation from the information supplied to us, or (ii) the employment of different door to frame gaps. The tested assemblies were asymmetrical and were tested such that doorset A opened towards the heating conditions of the test and doorset B opened away from the heating conditions of the test. The test result may not be appropriate to situations where by the samples tested have been installed in a different configuration to that which they are tested.

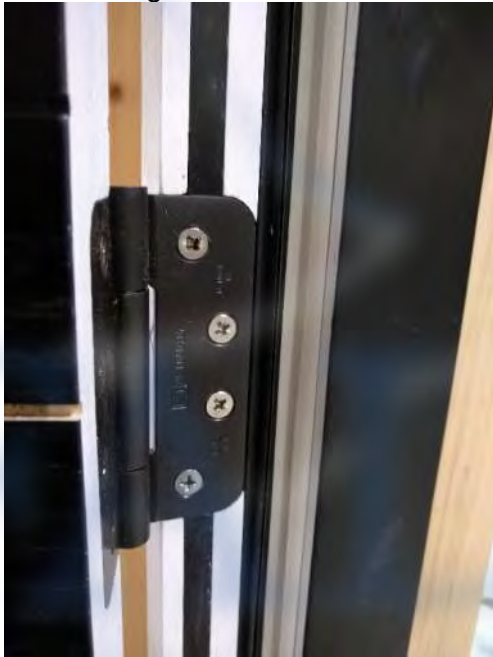
Make/type	Size (mm)	Location
Around hinge blade	Partially interrupted	-	Hinge blade fully interrupts 1 <sup>st</sup> seal leaving 2 <sup>nd</sup> seal continuous in frame reveal
Under hinge blades	Sealmaster graphite type intumescent	1 thick	Fitted under the hinge blade on frame and leaf
Around closer arm channel	Partially interrupted	-	Closer arm fully interrupts 1 <sup>st</sup> seal and partially interrupts 2 <sup>nd</sup> seal with 3mm remaining continuous in frame reveal
Under closer arm channel and closer body	Arrone intumescent kit	2 thick	Fitted as per the manufacturers instructions
Encasing latch bodies	Interdens	1 thick	Fitted around all latch bodies
Under latch forend	None fitted	-	-
Around centre latch keep	Partially interrupted	-	Centre latch keep fully interrupts 1 <sup>st</sup> seal with 2mm of 2 <sup>nd</sup> seal remaining continuous
Around top and bottom latch keeps	Partially interrupted	-	Top and bottom latch keeps partially interrupt both seals in frame reveal with 3mm of 1 <sup>st</sup> seal and

Intumescent interruption by hardware and additional intumescent protection

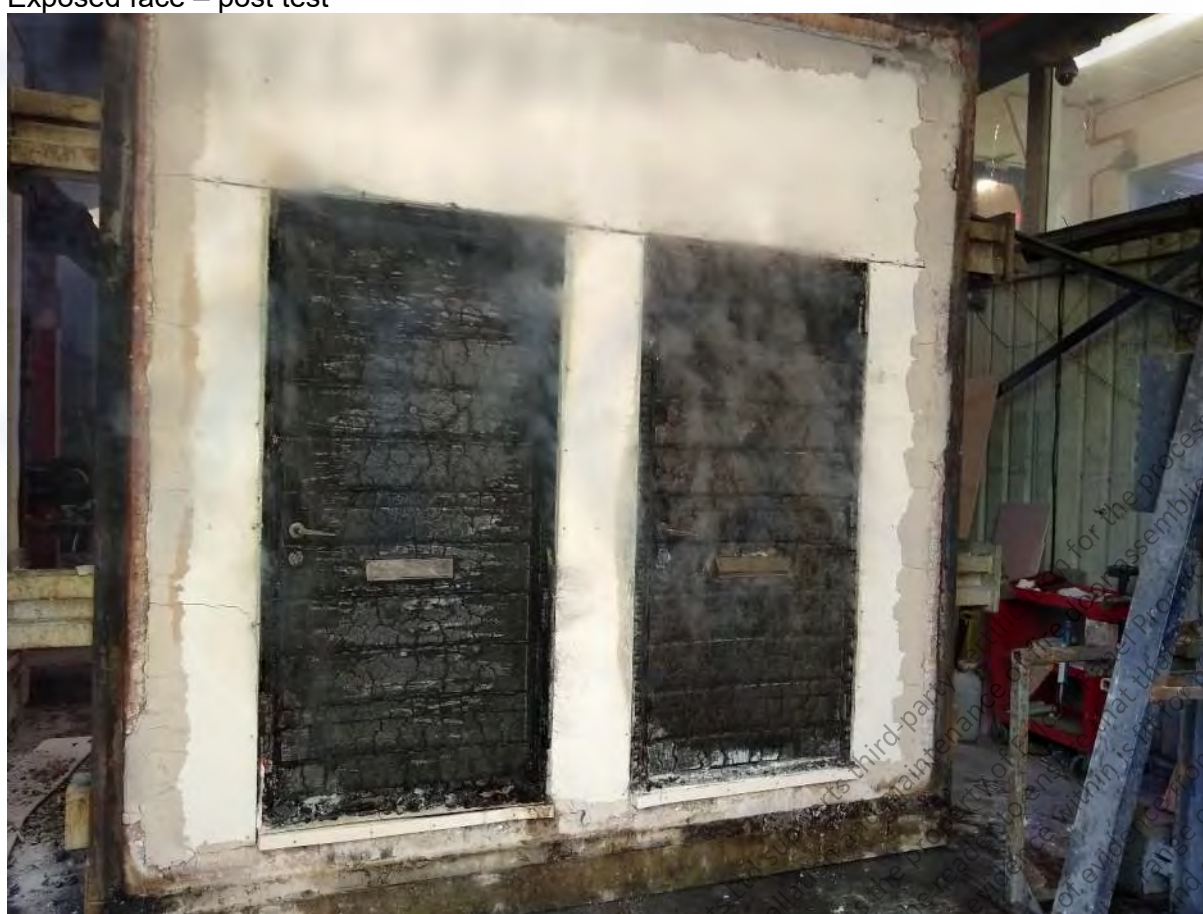
Exposed face – post test

35:21	Doorset B, There is discolouration at the latch position.
36:03	Doorset A, There is continuous flaming at the threshold thereby constituting <b>integrity failure</b> .

38:10	Doorset B, There is continuous flaming at the threshold thereby constituting <b>integrity failure</b> .
51:18	Doorset A, There is a glow visible at the top hanging corner.

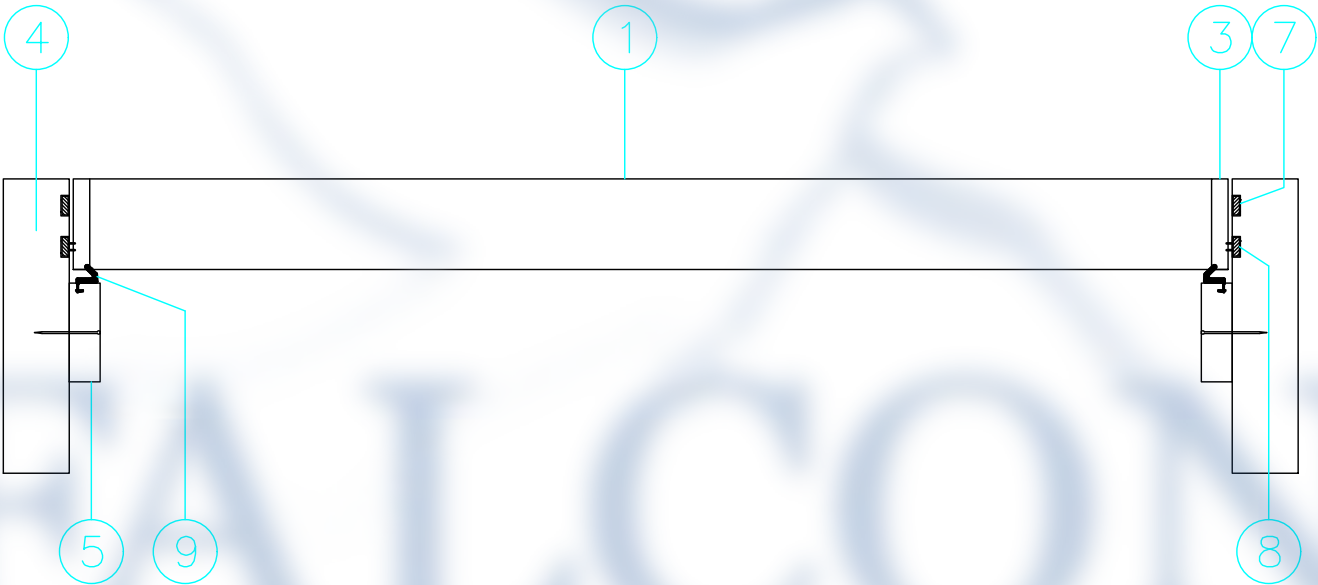
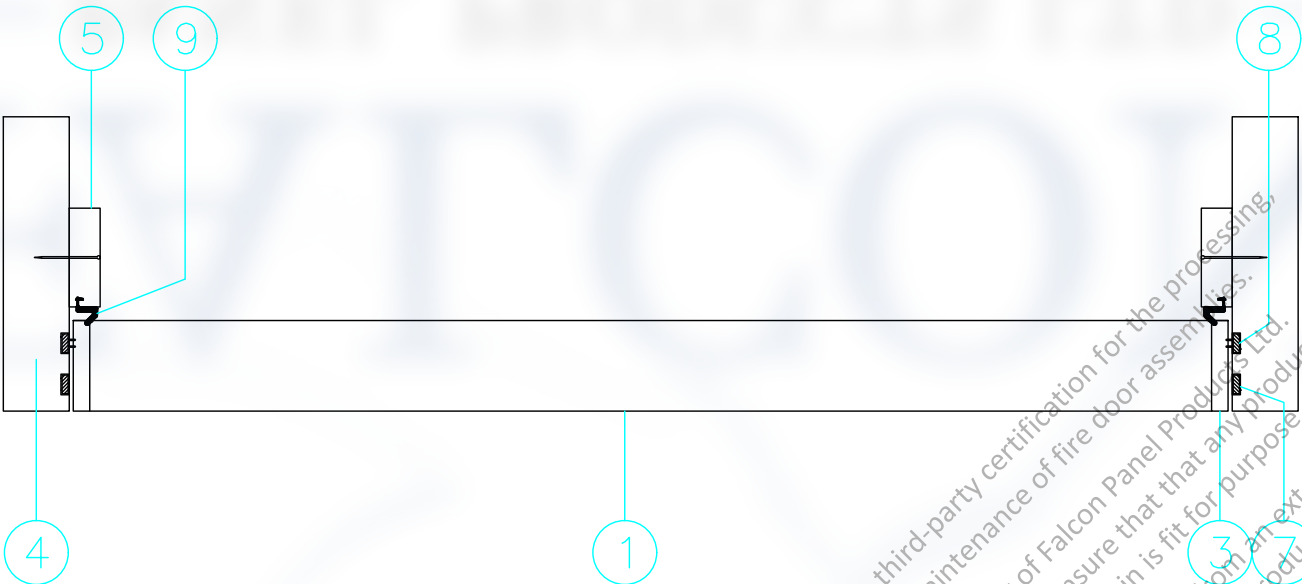
Title  
Horizontal cross-sections  
(All dimensions in mm)

Species/type	Dimensions (mm)	Density (kg/m <sup>3</sup> )	Moisture (% w/w)	Key to figures
Stiles and rails	None fitted	-	-	-	-
Core	Falcon Panel Products Strebord particleboard *	44 thick	630-635*	10.3-10.7	1
Decorative inserts	Ash fitted horizontally 50mm down and at 200mm centres*	10 x 10 including a 3 x 3 groove	-	-	2
Facings	Paper – fitted on the exposed face of doorset A and the unexposed face of doorset B	-	-	-	-
	Ash veneer - fitted on the unexposed face of doorset A and the exposed face of doorset B	-	-	-	-
Adhesive	Lippings	PUR*	-	-	-
	Inserts	PVA*	-	-	-
Lippings – vertical edges only	Ash	10 thick	710**	-	3

Species/type	Dimensions (mm)	Density (kg/m³)	Moisture (% w/w)	Key to figures
Head and jambs	Ash*	32 wide x 143 thick	710*	10.3-10.5	4
Stop – planted (pinned)	Ash*	15 wide x 48 wide	640*	8.9	5
Head to jamb jointing detail	Mortice and tenon - Butted - screwed	-	-	-	-
Frame to supporting construction fire stopping detail	Rock mineral wool for full depth of frame capped with Mann McGowan Pyromas A mastic on the exposed face.	Nominally 8 -12 wide x 10 deep (mastic size)	-	-	-
Frame to supporting construction fixing detail	3No. screws per jamb fitted at no more than 600mm centres, fixed through the stop	5Ø x 100 long	-	-	-
Architrave	None fitted	-	-	-	-
Threshold	Non combustible	-	-	-	-

Make/type	Size (mm)	Location	Key to figures
Leaf edge – bottom edge	Norseal Ref. 8105 drop seal	20 high x 12 wide	Centrally fitted along the bottom edge of the leaf	6
Frame reveal – head and jambs	Pyroplex Rigid Box Seal Ref. FO8500	10 x 4	Fitted 8mm from the opening face in the frame reveal	7
	Pyroplex Rigid Box SealTwin Flipper Ref. 30150	10 x 4	Fitted 28mm from the opening face in the frame reveal	8
Weather seal	Lorient Polyproducts Ltd LAS 1206	14 wide	Self-adhesive to the upstand of the stop	9

Section A-A

Section B-B

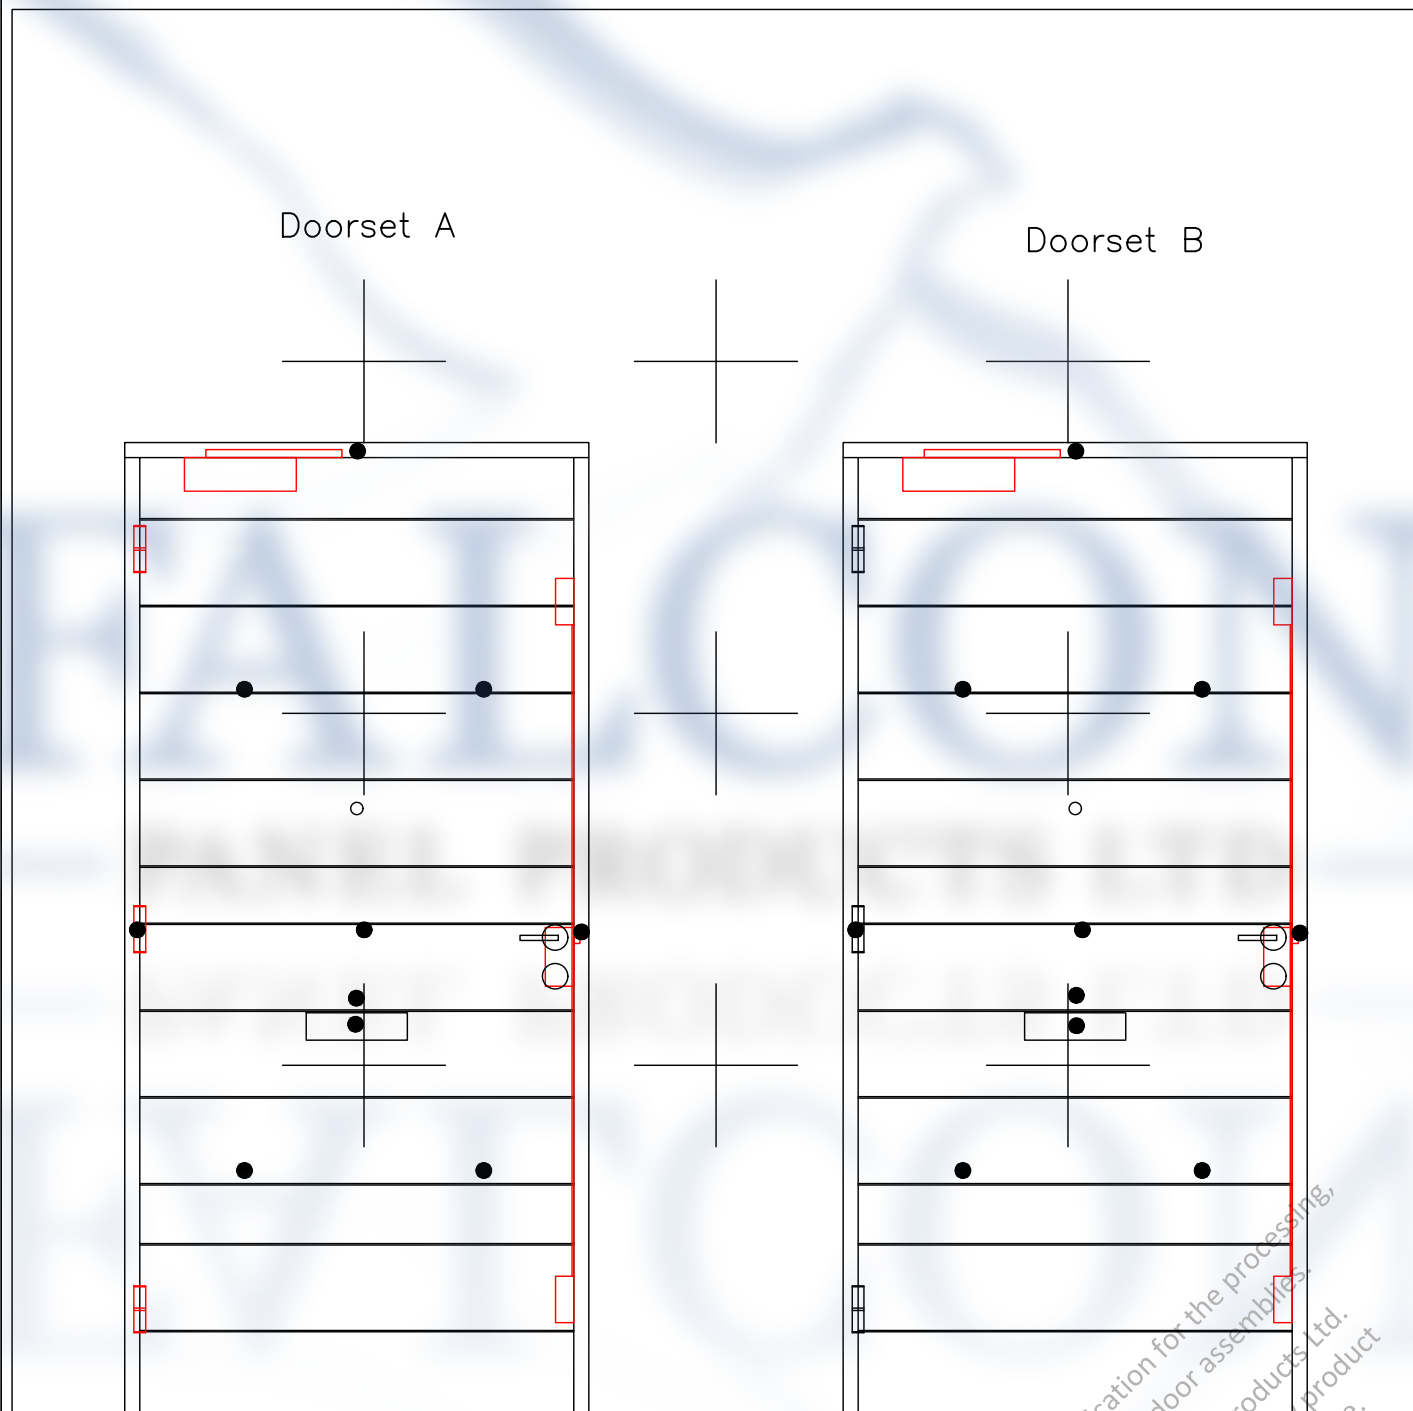
Title Thermocouple positions  
(All dimensions in mm)

✚ : Furnace Thermocouples  
● : Unexposed Face Thermocouples

Viewed From Unexposed Face
